BUILDING SCIENCE SERIES 40

Engineering Aspects of the 1971 San Fernando Earthquake

This report presents the observations of the NBS on-site inspection team (most photographs in this report were taken by the team). The material presented herein is intended to serve as (1) a documentation of damage resulting from the earthquake and (2) as a source document for further studies, research, and recommendations. This is particularly important as necessary remedial work and restoration have resulted in the removal of evidence that is essential for studies and evaluations.

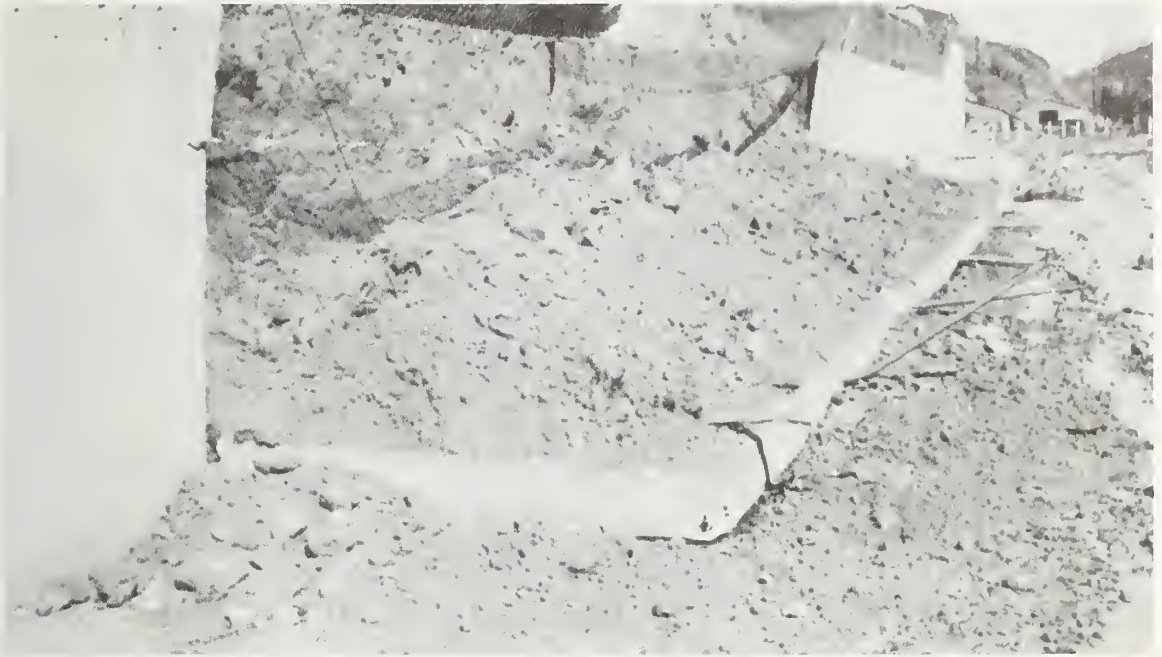
Figure 8.34 Lopez Canyon Channel. A 50-foot section of the wall has failed on the right bank. The 50-foot section adjacent upstream also shows severe structural damage.

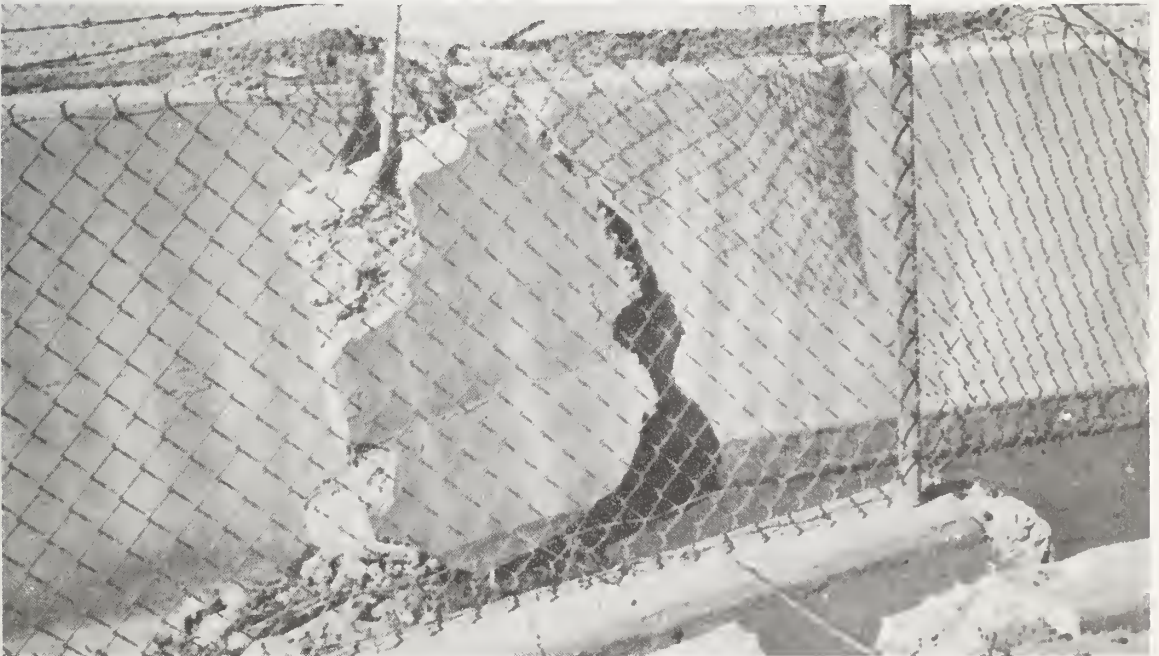
Figure 8.35 Lopez Canyon Channel. A 2-foot displacement of the channel had caused complete failure of the walls and invert, with the upstream portion moving over the downstream portion.
